# Natural bank erosion processes for habitat diversity in multifunctional rivers

Gonzalo Duró, Alessandra Crosato, Maarten G. Kleinhans, Wim S. J. Uijttewaal

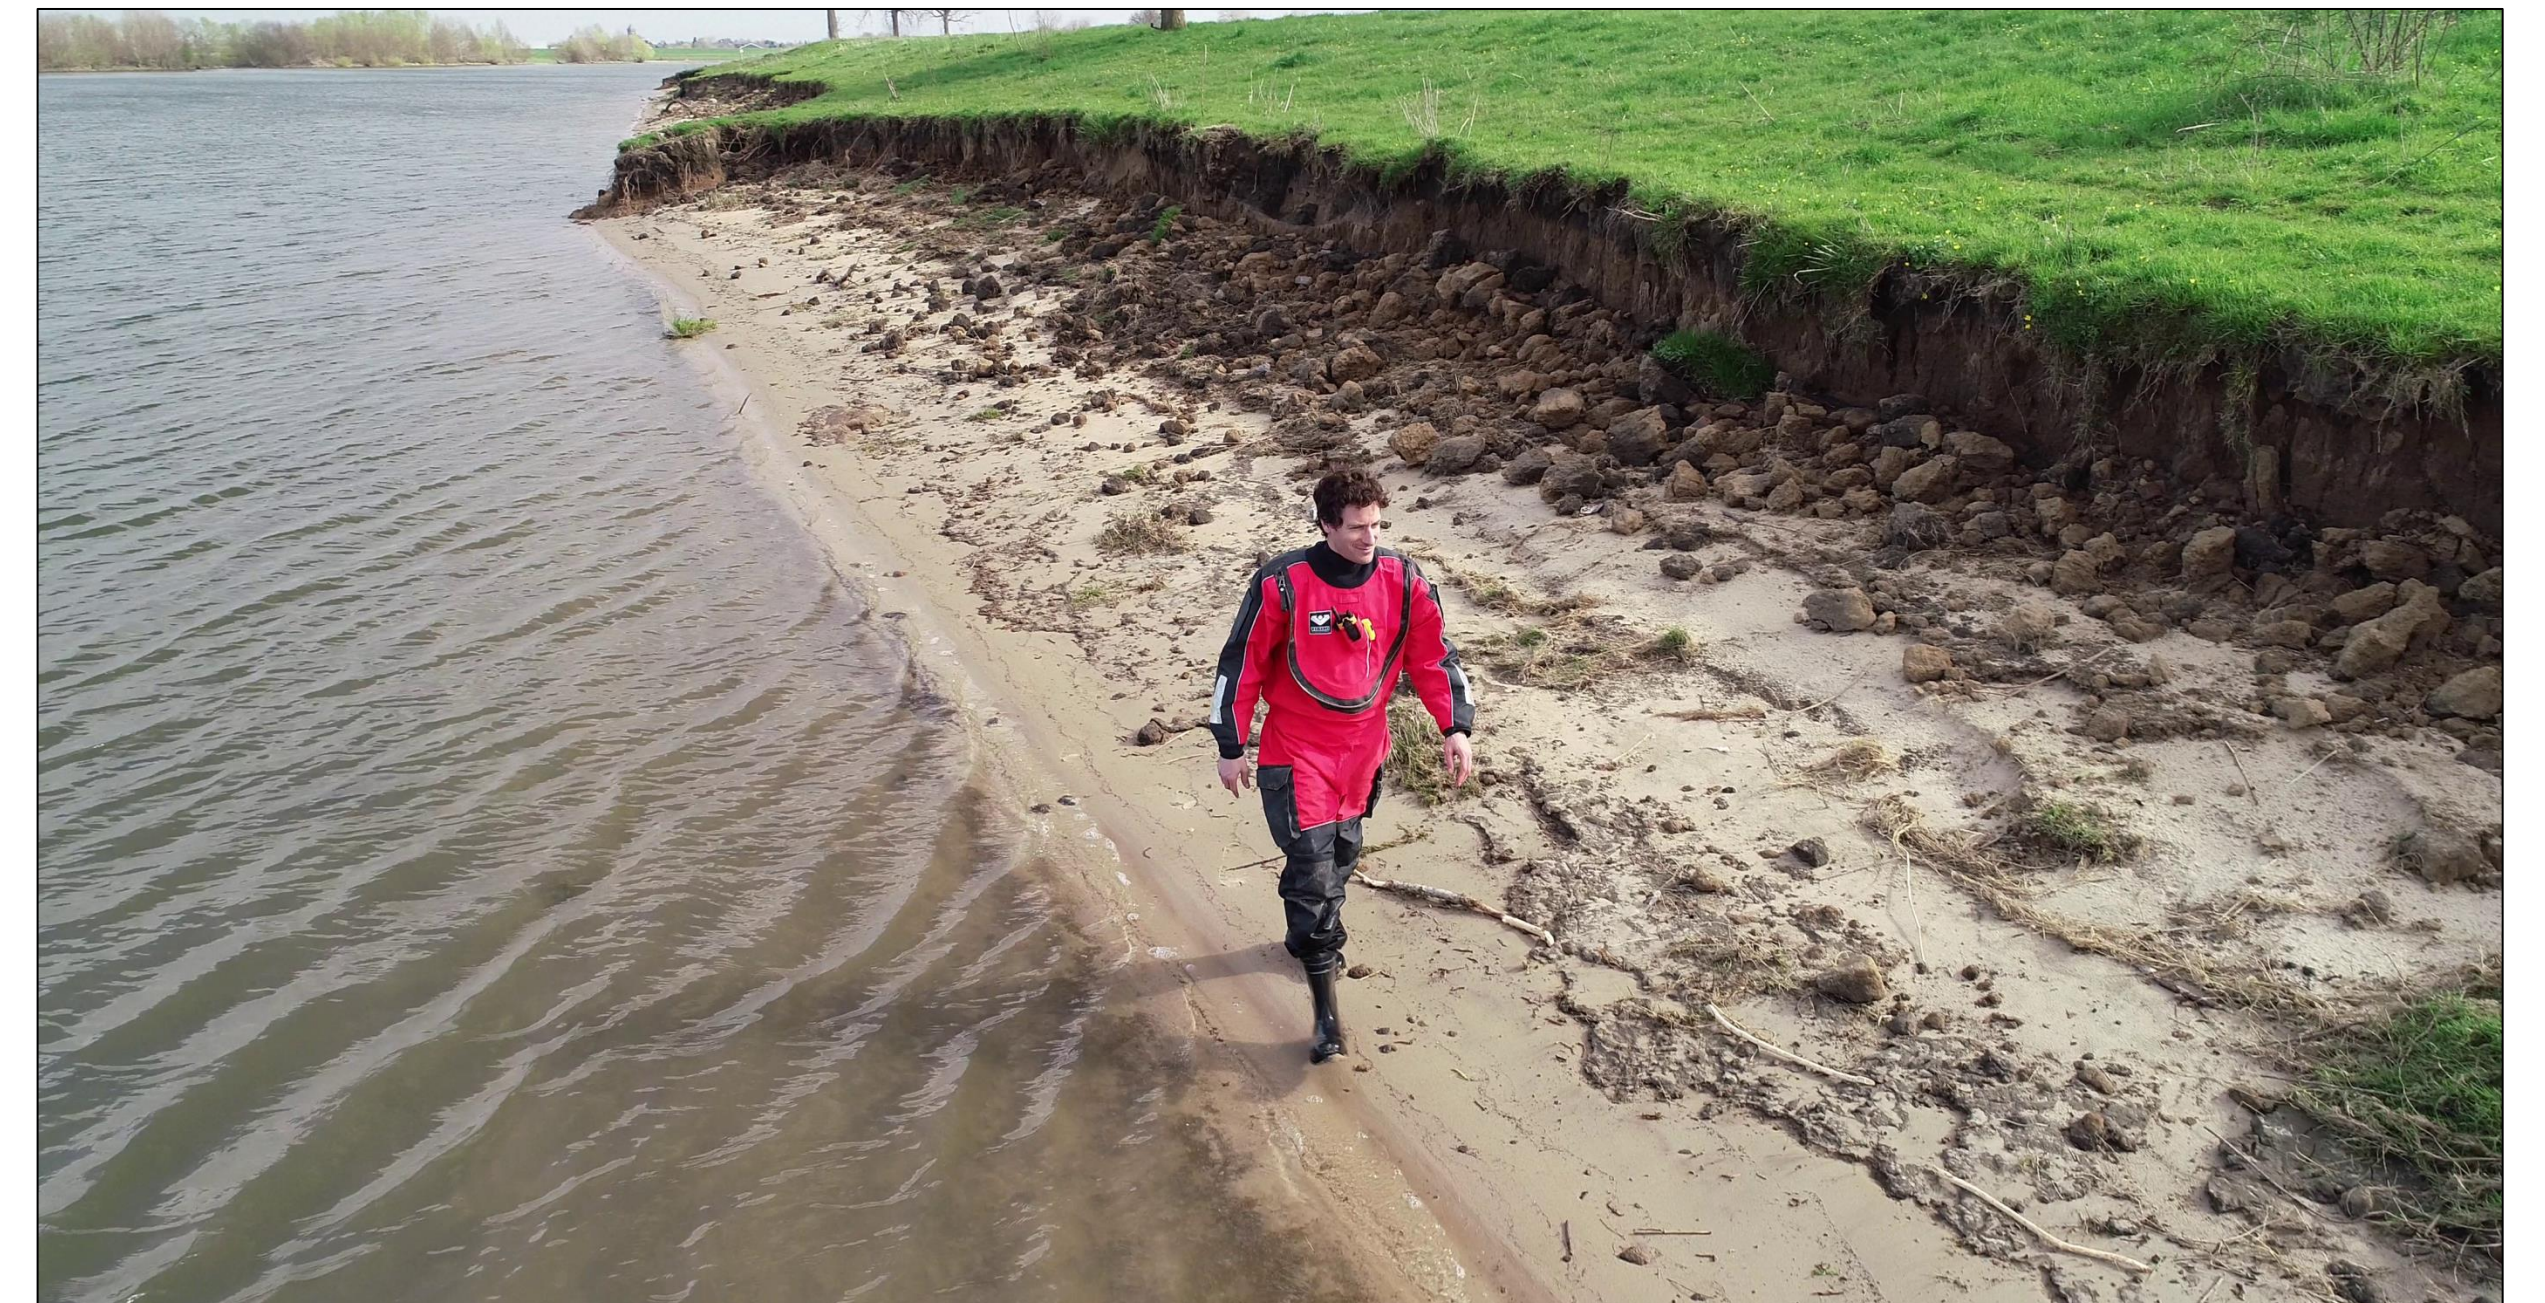
Inspection of eroding banks near Neerloon, the Meuse River.
